Incident: Grounding of Donald Searle: **Location:** Lulworth Cove

June 2022

Rona Sailing Project Incident Report Summary: #2

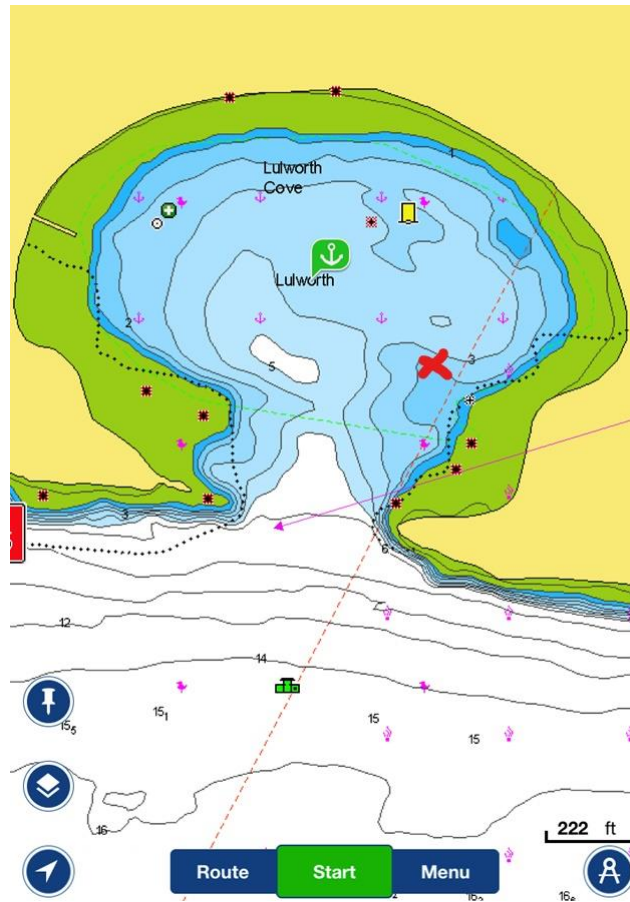
Figure 1 RED X, where Donald Searle was anchored.
