Incident: Grounding of Lady Shona: **Location:** Poole Harbour

Rona Sailing Project Incident Report Summary: #1

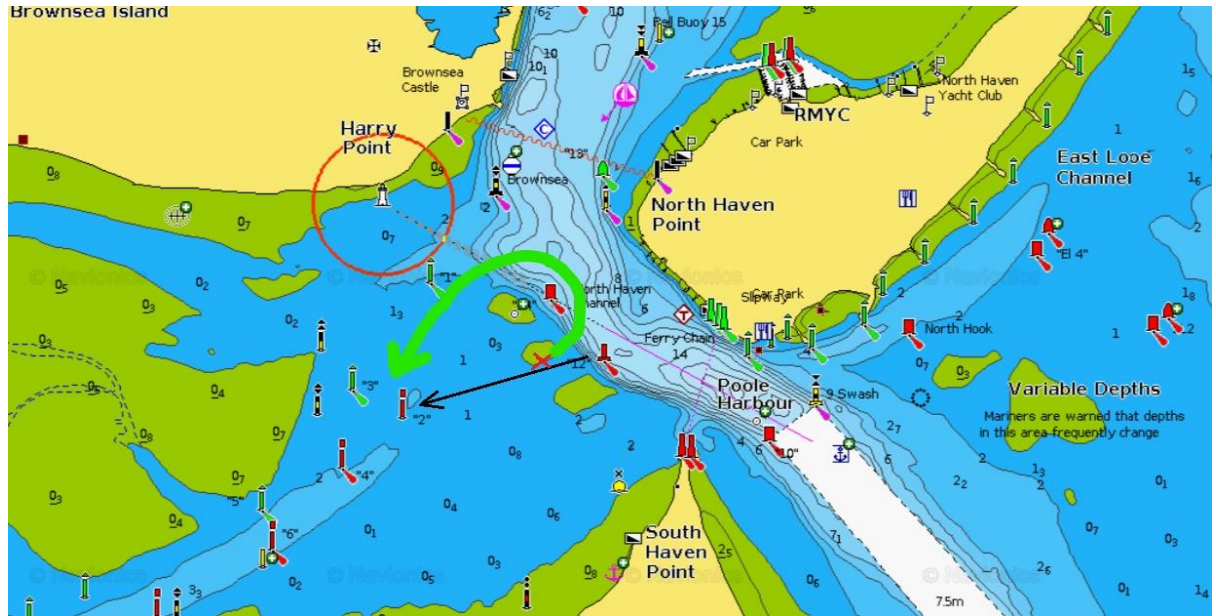
Summary of incident: Skipper tried to cut a corner between the main channel (PHM "12") and the South Deep Channel (PHM "2") in Poole Harbour. They were unable to hold the course and the starboard keel hit the sandbank. Engaging the engine, Lady Shona was successfully reversed off the sandbank and returned to the main channel and made the standard entrance to the South Deep channel around mark "14" (see picture below)

Black arrow: Intended course, which is out of the main channel which 'cutting the corner'

Red cross: Where contact was made with sandbank

Green: Route Lady Shona subsequently took, which is back in the main channel
