Incident: Grounding of Donald Searle at anchor	Location: Lulworth Cove	July 2022
---	--------------------------------	-----------

Incident Report # 4 Donald Searle grounding at anchor in Lulworth Cove

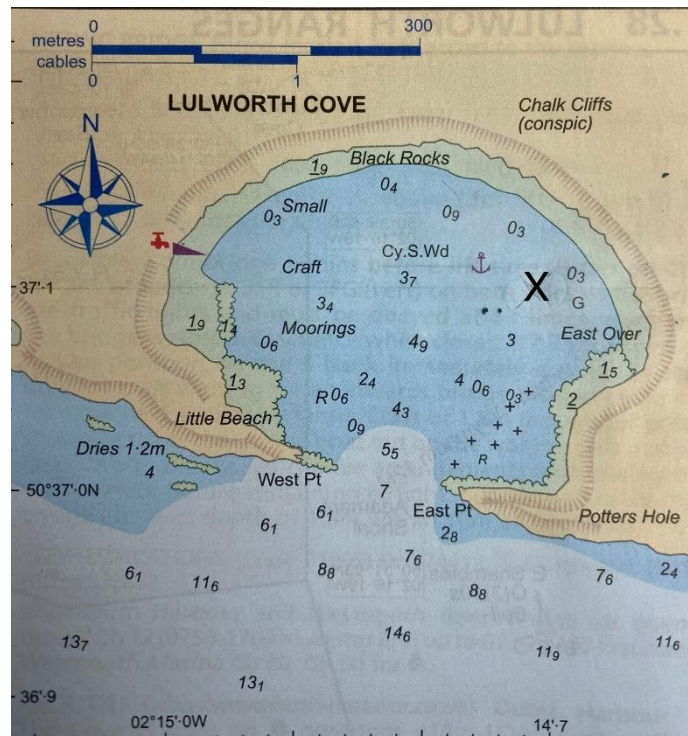
At 08h28am on the morning in question, Donald Searle anchored in Lulworth Cove in a depth of of 3.5-4.0m, with 20m of chain paid out. The tide was rising and the wind was force 2-3 from the NW. at 08h30 the boat swung on the anchor into shallow water of c.2.5m. Donald Searle's Draught is 2.59m.

The vessel was anchored too close to the coastline so the swinging effect led to the touch.

X: Donald Searle's position when anchored.

When anchoring in confined areas, AG to consider the potential for and effect of the vessel swinging.

Anchor in deeper waters in the centre of the cove.
