Nature of near miss:

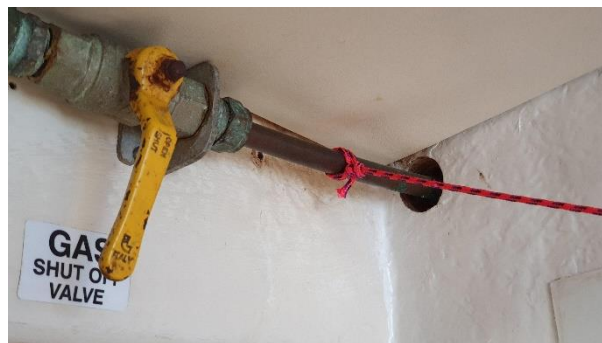
A 'washing line' was found rigged between the gas pipe and the vertical grab bar on the left side of the step down into the galley from the companion way:

While strong enough for a few tea towels, the line could be grabbed as a bracing point which would put a high load on the pipe by the isolating valve and could cause it to fail. If this had happened, it could very easily have pinched the copper pipe or compromised the shut off valve connected with a compression fitting, adjacent to the tie off point for the washing line.

Worst case scenario would be a gas leak on the supply side of the shut off valve which would require isolation at the bottle (1/2 minutes from being found / reported)

Lack of appreciation for how fragile a copper pipe and compression fitting is compared to the potential force of a heavy fall grabbing the line which was hanging in space approx. 6/8 inches below ceiling height parallel to the main companionway.

Do not tie anything to a gas pipe and find safe alternative for drying tea towels.
